DEPARTMENT OF TRANSPORTATION**DIVISION OF ENGINEERING SERVICES**

Office of Structural Materials

Contract #: 04-0120F4Cty: SF/ALA Rte: 80 PM: 13.2/13.9File #: 1.28**WELDING INSPECTION REPORT****Resident Engineer:**Pursell, Gary**Address:** 333 Burma Road**City:** Oakland, CA 94607**Report No:** WIR-016059**Date Inspected:** 04-Aug-2010**Project Name:** SAS Superstructure**OSM Arrival Time:** 700**Prime Contractor:** American Bridge/Fluor Enterprises, a JV**OSM Departure Time:** 1530**Contractor:** American Bridge/Fluor Enterprises, a JV**Location:** Jobsite**CWI Name:** See below**CWI Present:** Yes No**Inspected CWI report:** Yes No N/A**Rod Oven in Use:** Yes No N/A**Electrode to specification:** Yes No N/A**Weld Procedures Followed:** Yes No N/A**Qualified Welders:** Yes No N/A**Verified Joint Fit-up:** Yes No N/A**Approved Drawings:** Yes No N/A**Approved WPS:** Yes No N/A**Delayed / Cancelled:** Yes No N/A**Bridge No:** 34-0006**Component:** SAS OBG**Summary of Items Observed:**

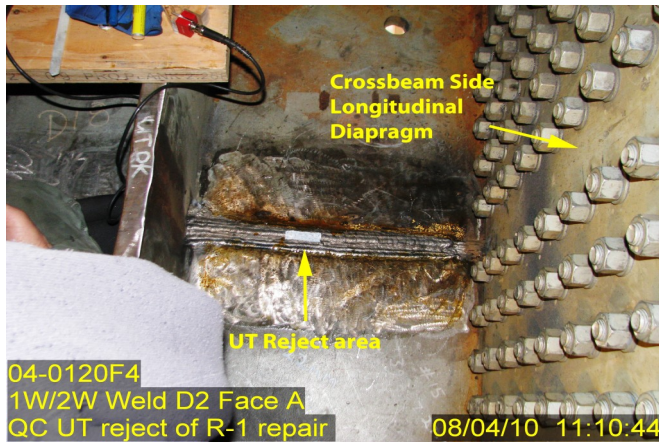
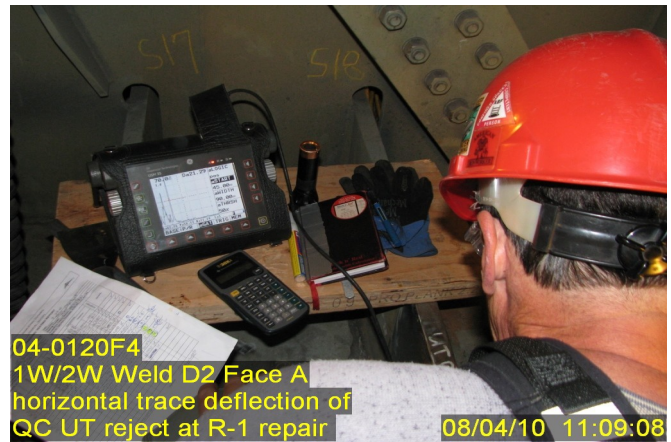
The QAI periodically observed QC Inspector Tom Pasqualone performing Ultrasonic Testing (UT) of repair cycle 1 (R-1) UT repairs from the A Face of OBG Field Splice 1W/2W Weld ID: D1 and D2. The QAI observed Mr. Pasqualone utilized the UT Procedure identified as SE-UT-D1.5-CT-100 Rev.4 during the examination of the splice weld. The QC technician performed the required shear wave testing during the testing for weld soundness utilizing a .63 x .75 rectangular transducer. The QAI observed that The QC Inspector had marked some areas that appeared to be UT rejects. See Summary of Conversations. The UT examination was completed from face A during the QA Inspectors shift and the work at this location appeared to be in general compliance with contract documents. See photos below of QC UT rejectable indication detection and marking.

At the completion of the UT from face A at this location the QA Inspector asked how many areas had been rejected. The QC Inspector stated that 3 areas were class A rejects from the A Face and several more areas were not rejectable from the A Face but maybe from the B Face.
